NASA TM X-2950

**EXAMINATION OF T-111 CLAD URANIUM
NITRIDE FUEL PINS IRRADIATED
UP TO 13 000 HOURS AT
A CLAD TEMPERATURE OF 990° C**

*by Jack G. Slaby, Byron L. Siegel,
Kenneth J. Bowles, and Robert J. Galbo*

*Lewis Research Center
Cleveland, Ohio 44135*

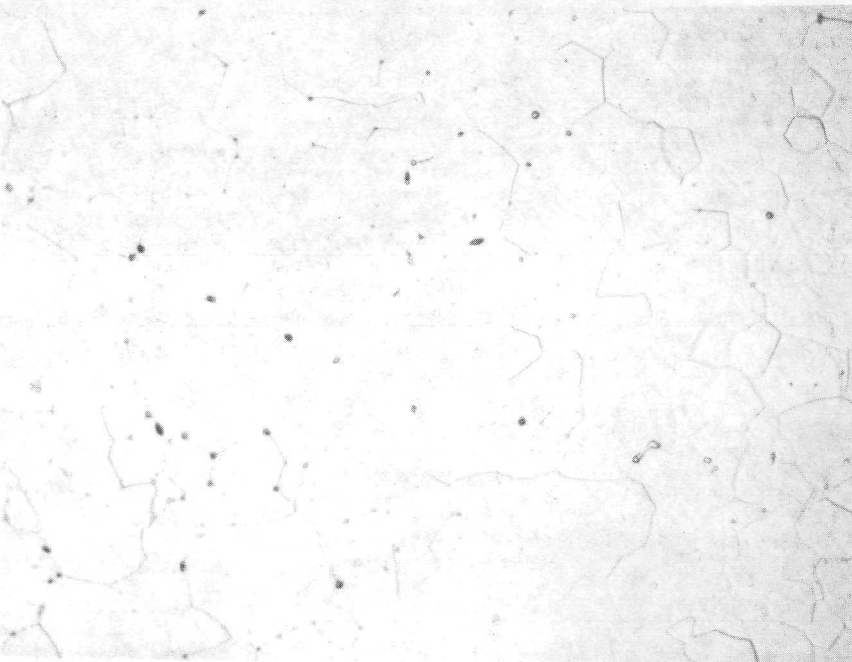
Pin 503B. - This pin was subjected to metallographic examination with a large amount of work directed to the top end cap in search of a leak emanating from the thermocouple well. The generally clean appearance of the end cap is shown in figure 18. The area of the leak is shown in figure 19. This is a section of the wall of the machined thermocouple well that is near the final closure weld in the end cap. The large amount of grain pullout and separated grains could be due to either a void in the original material or from a contaminant penetrating the grain boundaries. The cause was not determined.

Figure 18. - Top end cap material, (T-111) of fuel pin 503B. Etched. X250.

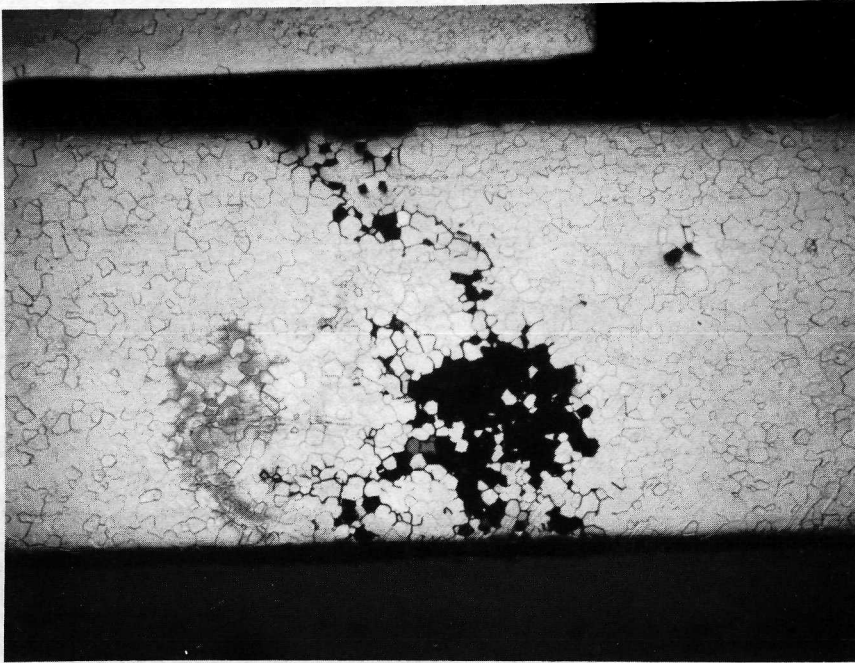
Figure 19. - Portion of top end cap material, (T-111) between closure weld hole and thermocouple well of fuel pin 503B. Etched. X50.

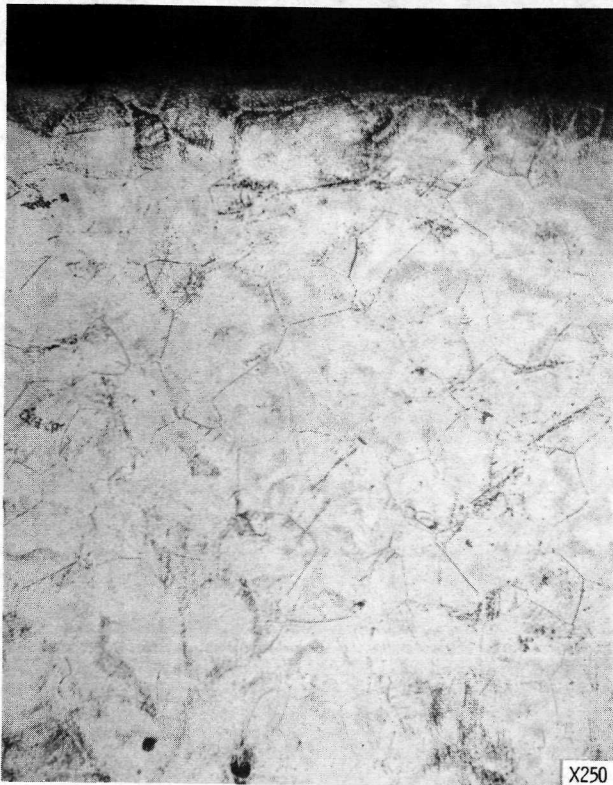
Pin 503C. - The fuel from this pin is shown in figure 21 and appears unchanged from the thermally aged fuel; no fission gas bubbles or second phases are visible. Figure 22 shows the microstructure of the cladding from near the axial center of the pin.

Figure 22. - T-111 cladding sample from fuel pin 503C showing heavy precipitation in metal. Etched.

(4) Results of ductility tests, inert fusion gas analyses, and metallography (heavy precipitates in pins 503C and 504B) taken together suggest that a small amount of oxygen contamination of the T-111 cladding occurred. Of the 27 irradiated pins these fuel pins (503C and 504B) are the only ones that appeared to have contaminated cladding. The third fuel pin (503B) exhibited a microstructure similar to that of thermally aged unirradiated T-111 cladding.

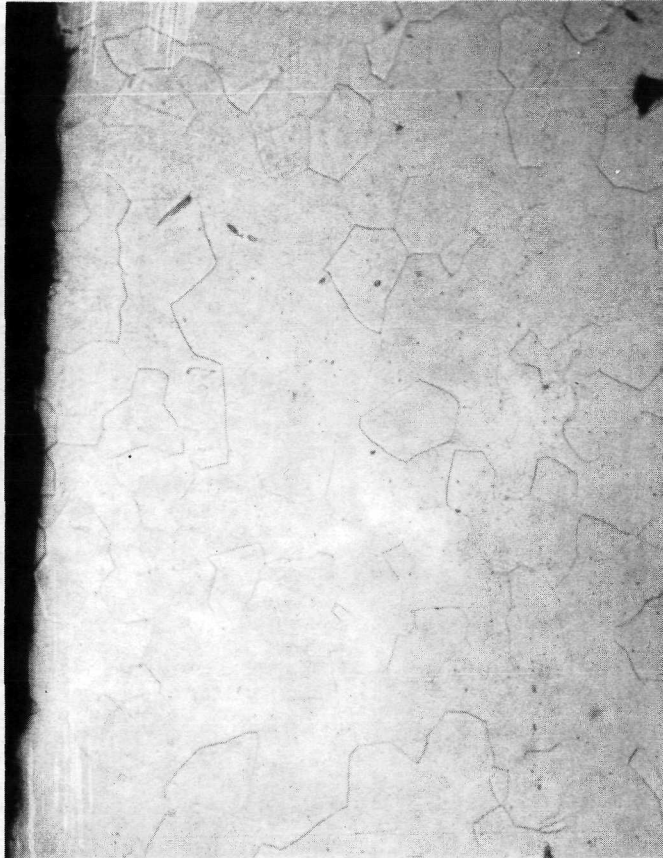
Figure 23. - Top T-111 cladding of fuel pin 503C near end cap. No precipitates are visible. Etched. X250.
